Storm Damage Report

Knights Inn
1121 9th Avenue SW
Bessemer, AL 35023

FIELD REPORT FOR INITIAL STORM DAMAGE INVESTIGATION

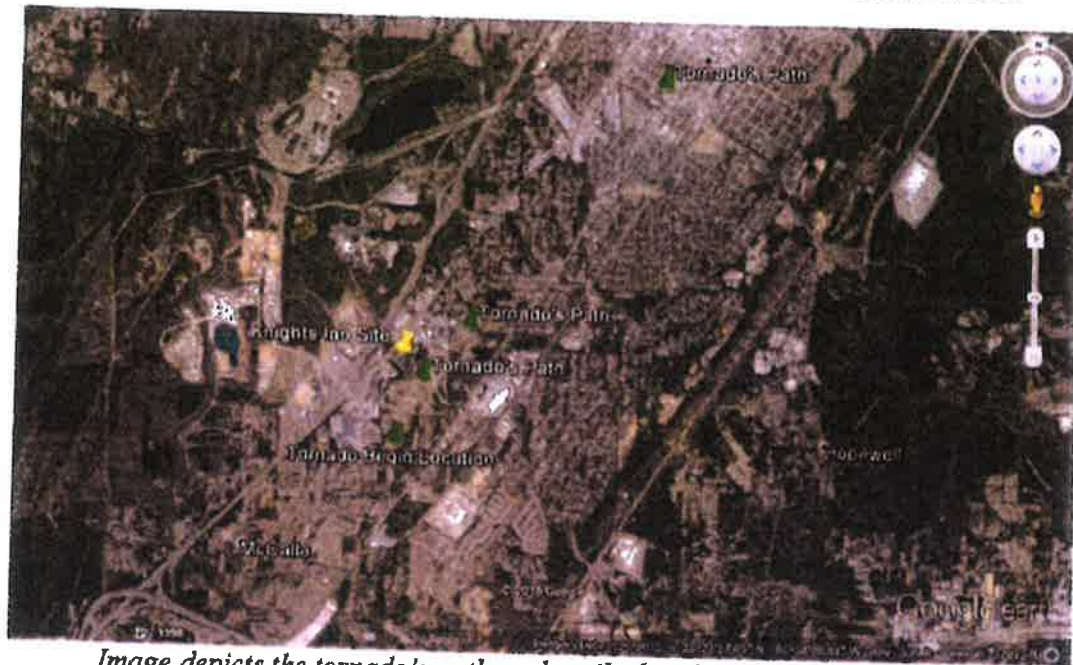
Image depicts the tornado's path as described in the narrative from NOAA Report #523012.

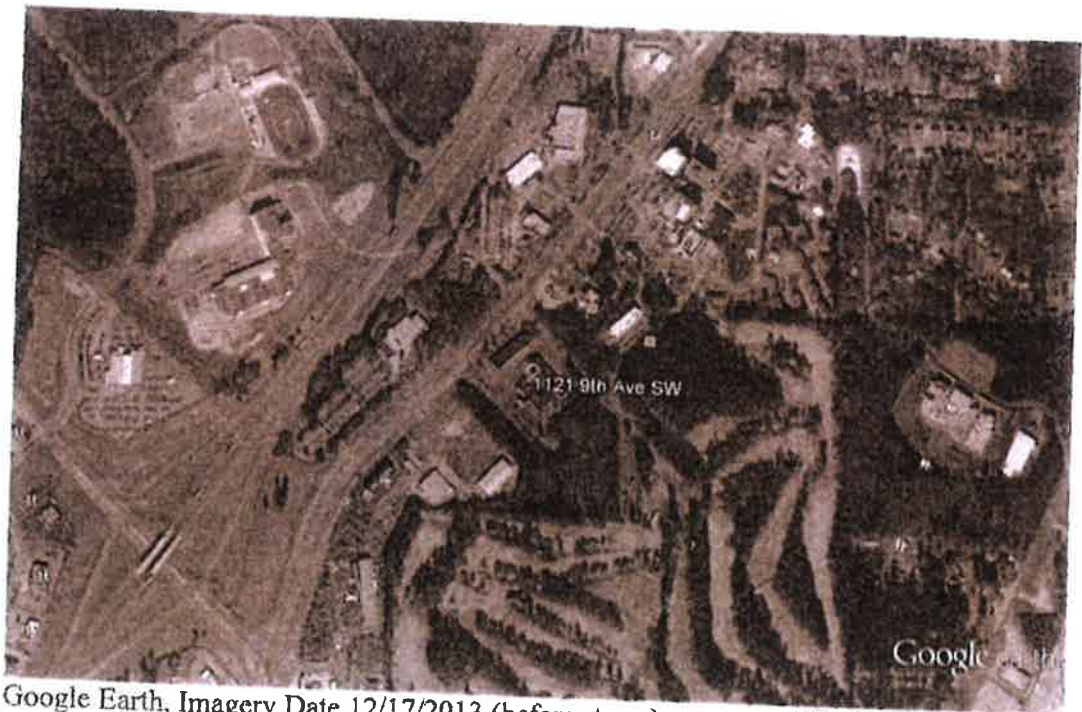
Google Earth, Imagery Date 12/17/2013 (before storm), approx. 2,600 ft radius.

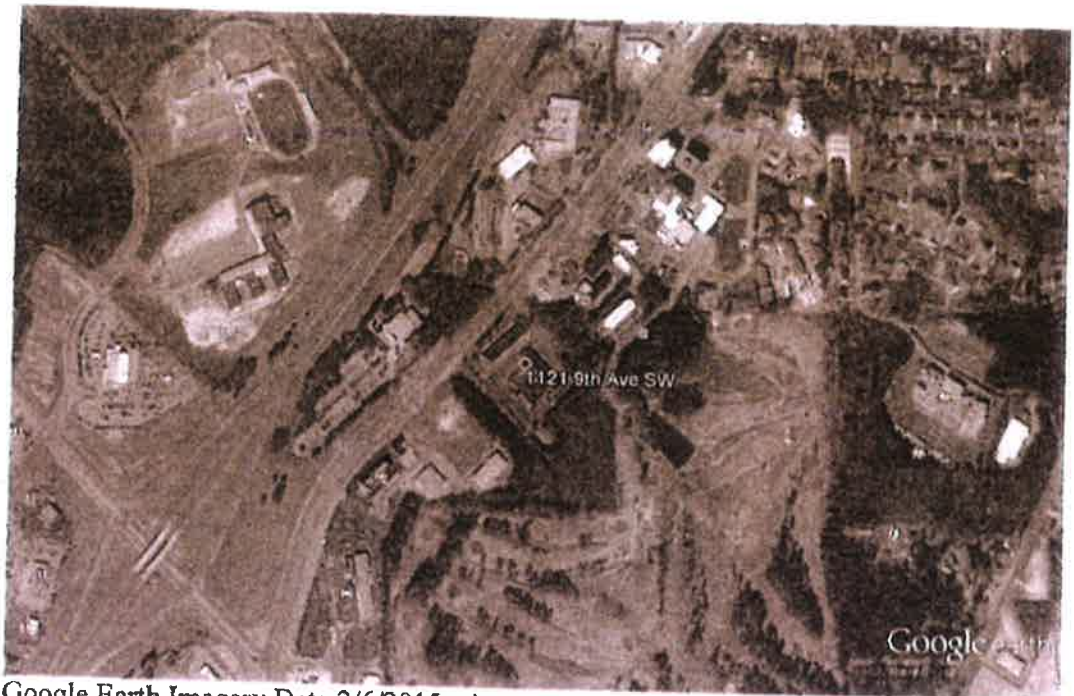
Google Earth Imagery Date 2/6/2015 – large areas of trees to east and south gone.

- Area is surrounded by open space and sparse low-rise commercial buildings which is inconsistent with the definition of Exposure B in ASCE 7, Exposure C applies.

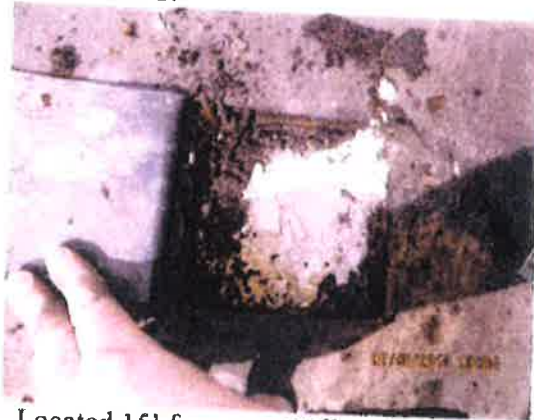
Core Cut #1:

- Located 15' from east wall and 20' from north wall.
- 60 millimeter EPDM single ply membrane. (Figure 46)
- 1/2" of actively wet fiberboard. (Figure 79)
- previous roof membranes left in place, \approx 3 (Figure 82).
- 2" of LWIC.
- Corrugated roof deck.

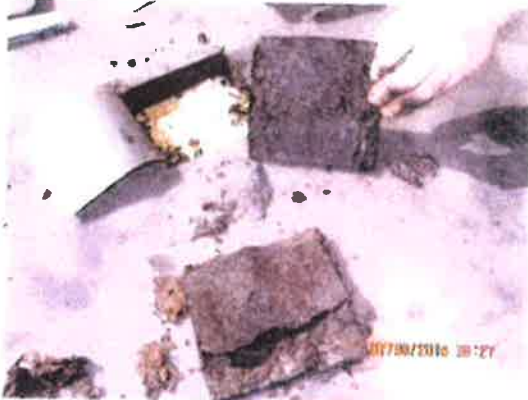
Core Cut #2:

- Located 16' from west wall and 51' from south wall.
- 60 millimeter EPDM single ply membrane.
- visually $\frac{1}{2}$ " of actively wet fiberboard cover board, saturated (Figure 92).
- previous roof membranes left in place, ≈ 3 (Figure 98).
- Tan cementitious material, visually LWIC, wet (Figure 99).

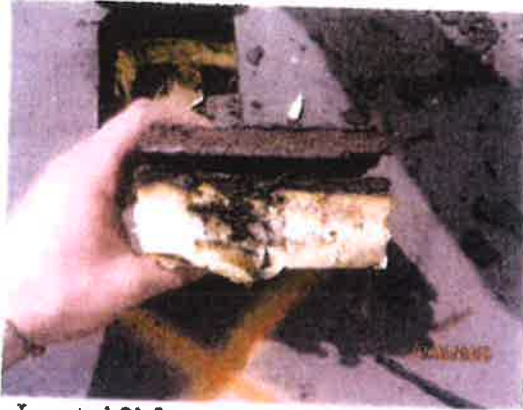
Core Cut #1:

- Located 8' from south wall and 10' from west wall.
- EPDM with active water (Figure 38).
- 1/2" of saturated fiberboard (Figure 39).
- previous roof membranes left in place, ≈ 3 (Figure 44).
- 2" of wet foam insulation (Figure 44).
- 2" Lightweight insulating concrete (LWIC).
- Corrugated metal roof deck.

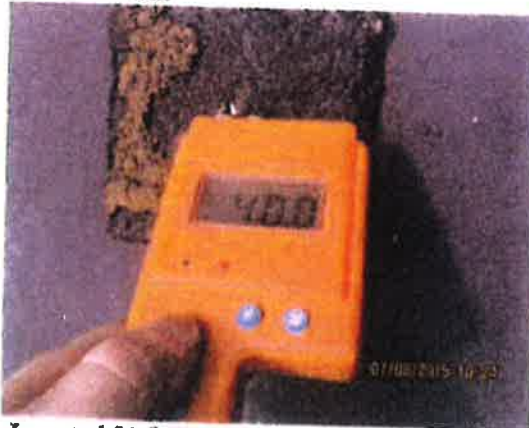
Core Cut #2:

- Located 3' from south wall and 10' from west wall.
- Fiberboard peeled off with membrane (Figure 63).
- Fiberboard saturated (Figure 67).
- Previous roof membranes, ≈ 3 (Figure 69).
- 2" wet foam insulation – visually isocyanurate rigid foam board. (Figure 69).
- Wet LWIC substrate (Figure 71).

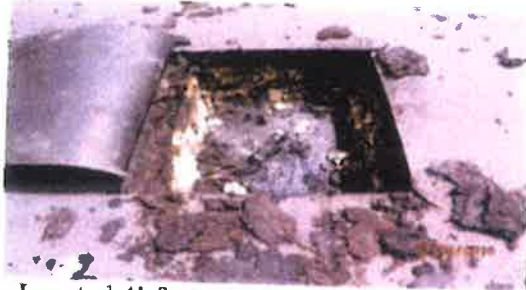
Core Cut #1:

- Located 4' from west expansion and 4' from north wall.
- Active water on underside of EPDM (Figure 41).
- 1/2" of saturated and friable fiberboard (Figure 42).
- previous roof membrane, \approx 3 (Figure 49).
- 2" of foam insulation (Figure 45).
- 2" of actively wet LWIC (Figure 48).
- Corrugated metal roof deck.

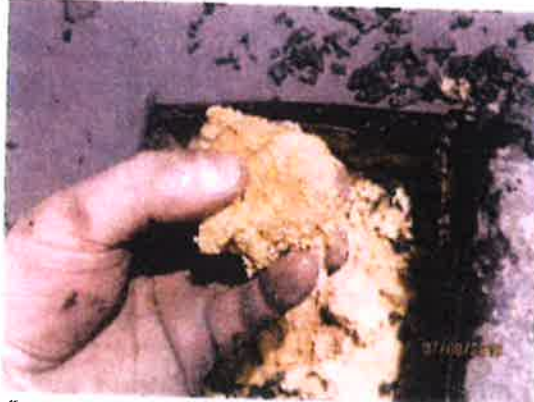
Core Cut 2:

- Located 3' from the south wall and 10' from the west wall.
- Active water underneath EPDM (Figure 61).
- Saturated fiberboard (Figure 65).
- Wet rigid insulation (Figure 67).
- Base sheet (Figure 68).
- Friable and wet cementitious material (LWIC) (Figures 70-72).
- Corrugated metal deck.

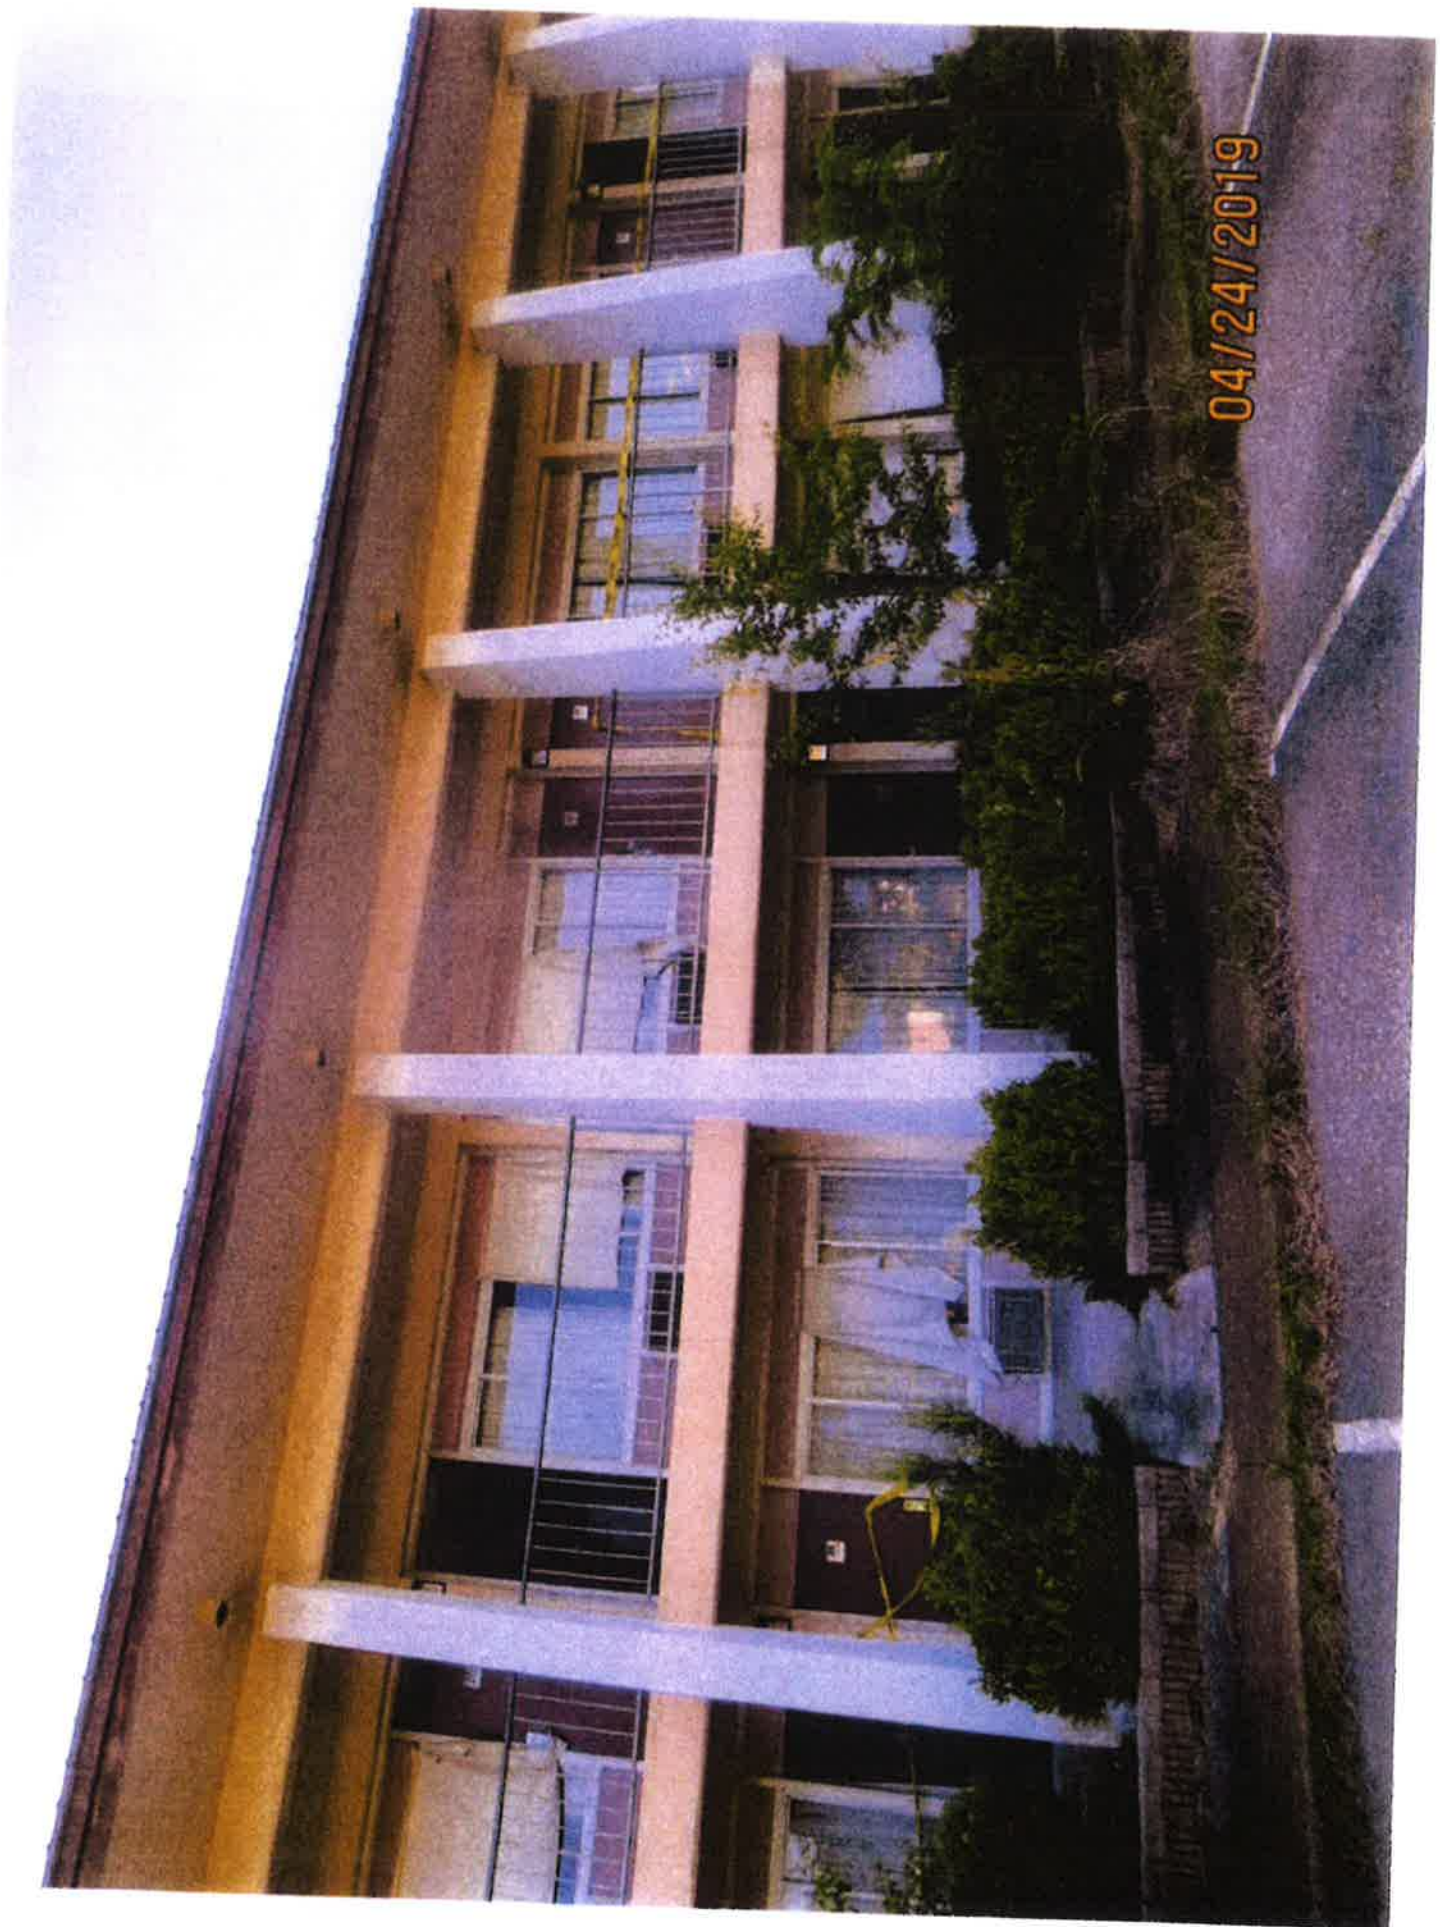
This building is unsafe and its use or occupancy has been prohibited by the BUILDING DEPARTMENT
